Montrose Chemical Corporation

**Metal Concentrations in Soil With Proposed Soil Sampling Locations**

Date: 03-05	Montrose Superfund Site	Figure 25
Project No. 76465	<b>EarthTech</b> A Tyco International Ltd. Company

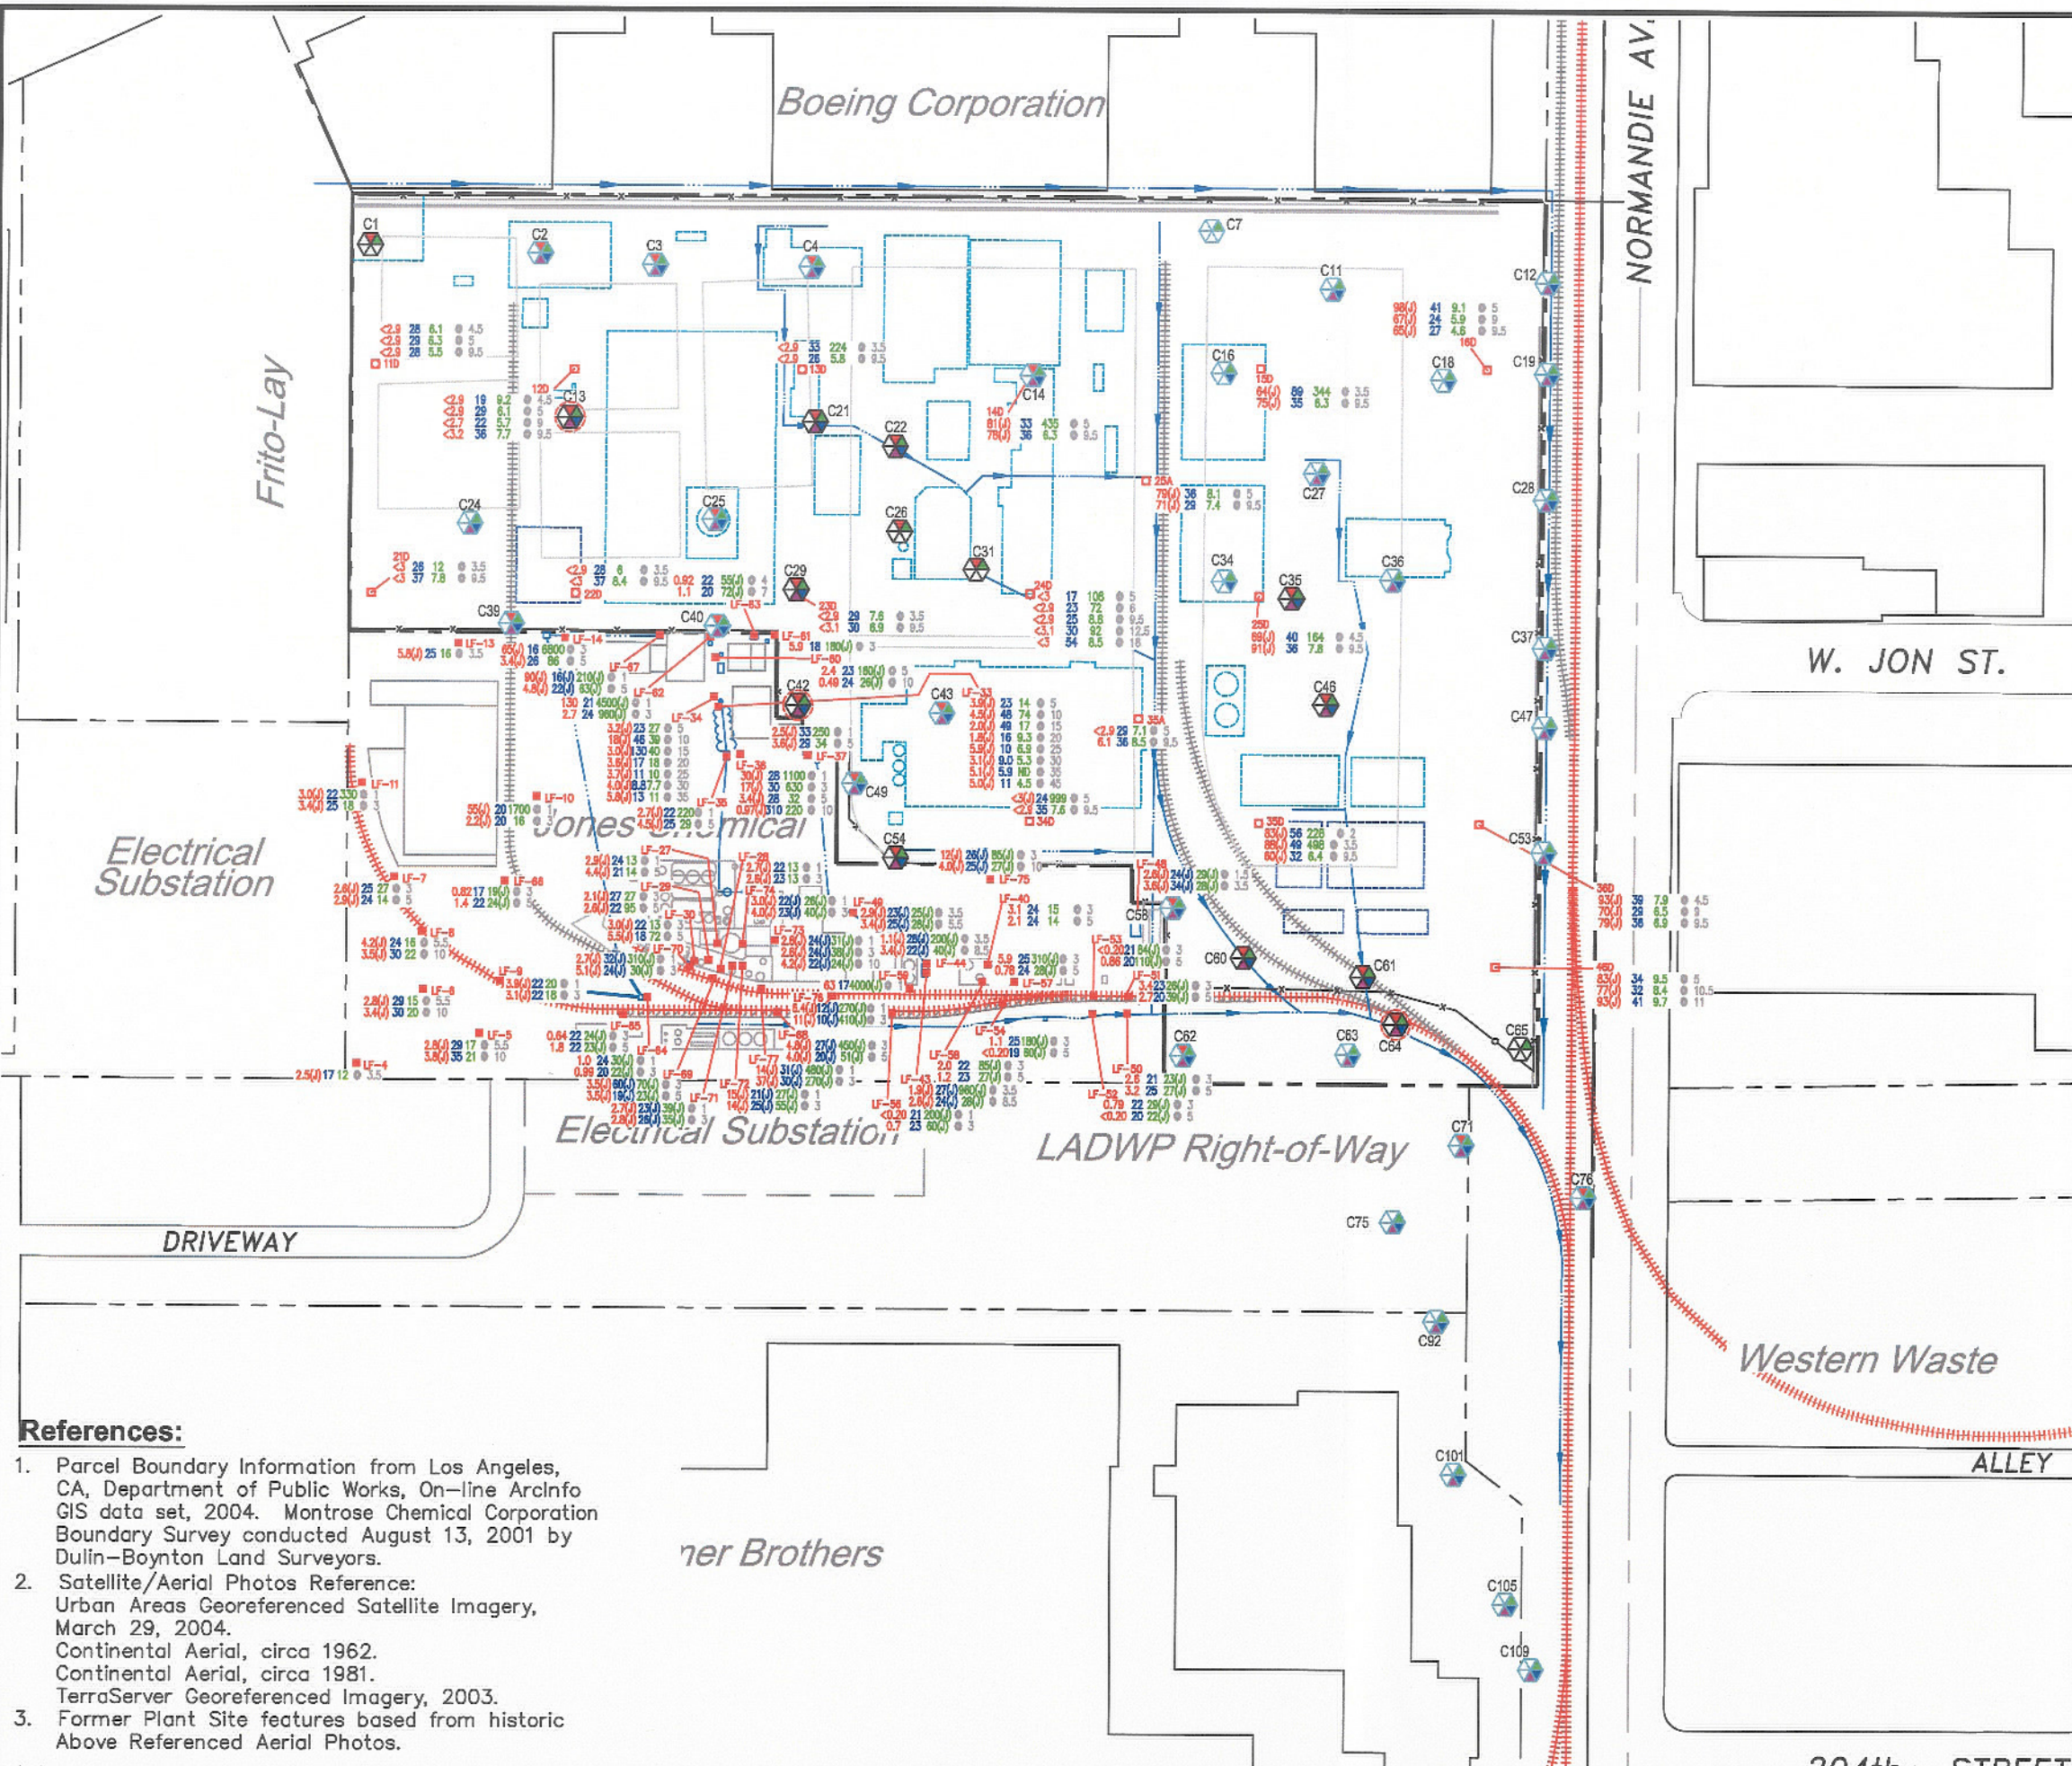
1. Proposed soil boring locations shown only where Metals will be sampled.

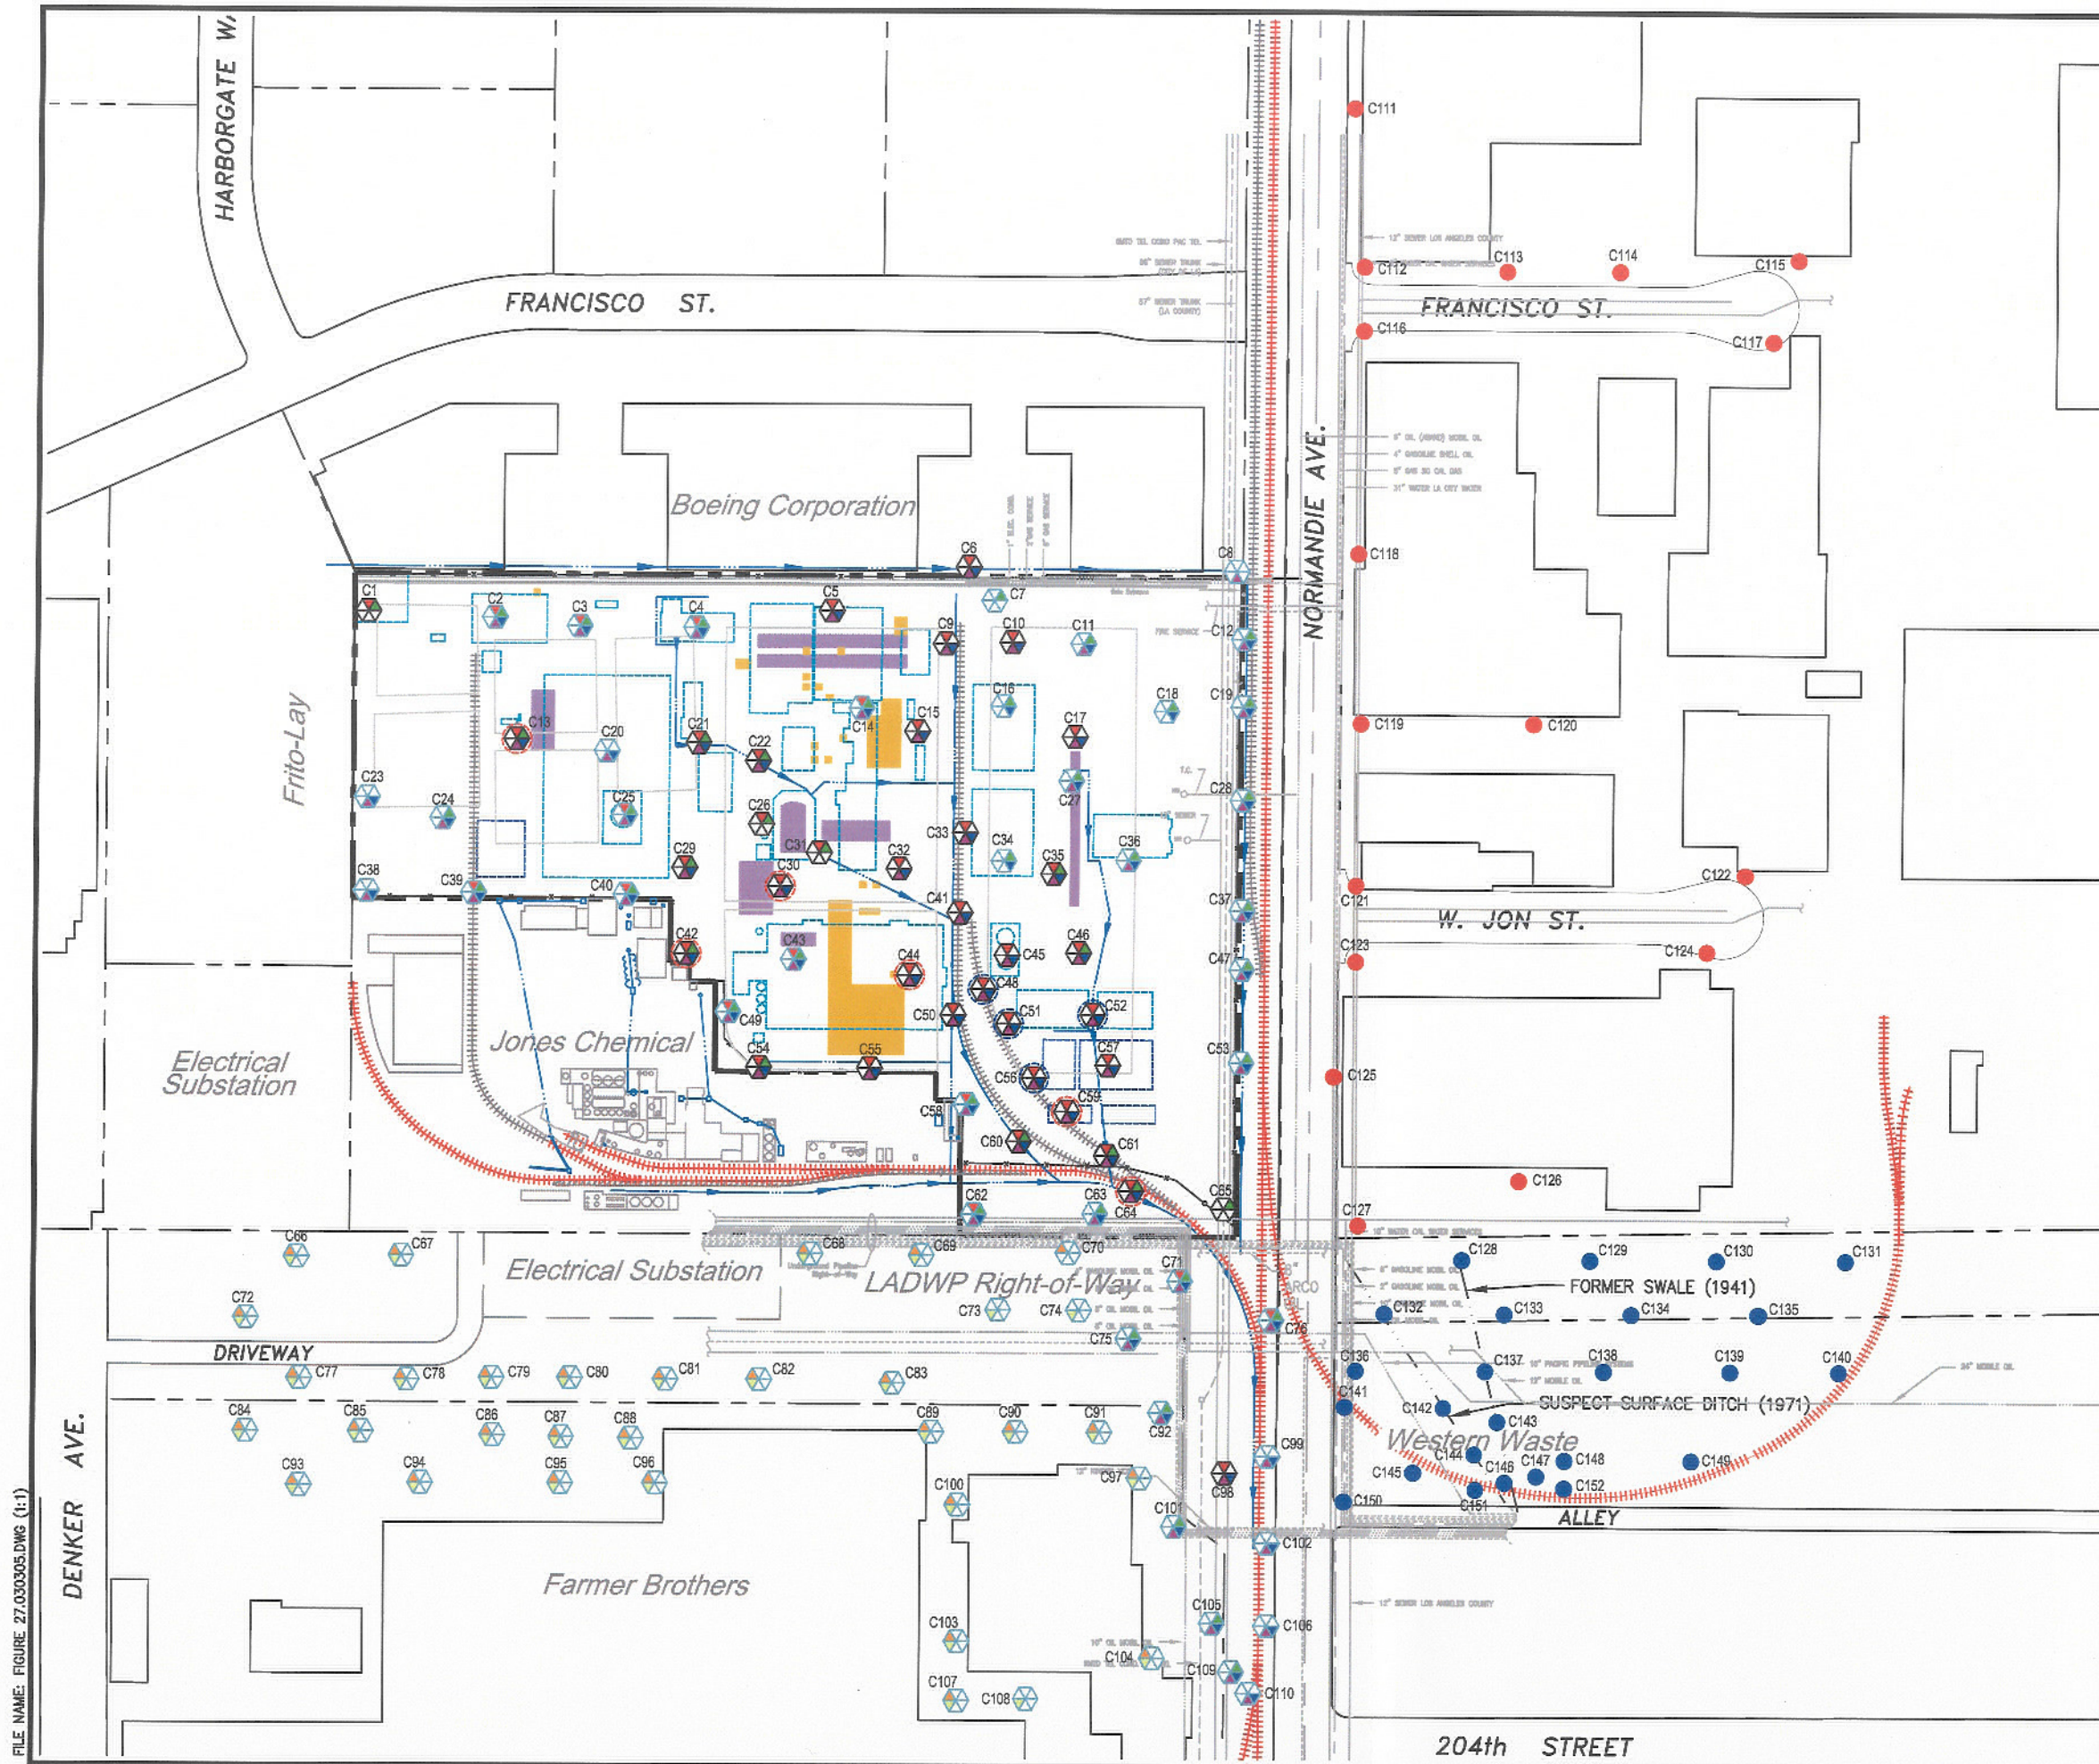
Date: 03-05	Montrose Superfund Site	Figure 27
Project No. 76485	 A Tyco International Ltd. Company

**Obstructions to Sampling Locations  
With Proposed Soil Sampling Locations**
